Forensic Investigation of Electrical Conduct Copper Bead Microstructure as an Effort to Identify Causes of Fire

Sulistiana Agung Riyanto¹, Deni Ferdian²

^{1,2}Department of Metallurgy and Material Engineering, Faculty of Engineering, Universitas
Indonesia

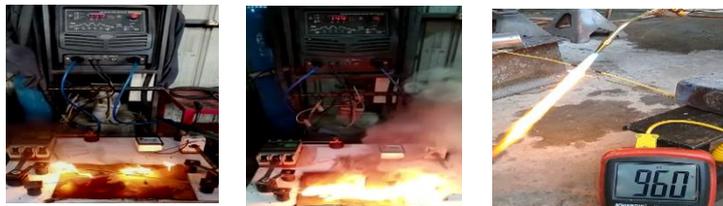
Figure 3.1 Short Circuit, Overload and Direct Flame treatment experiments.

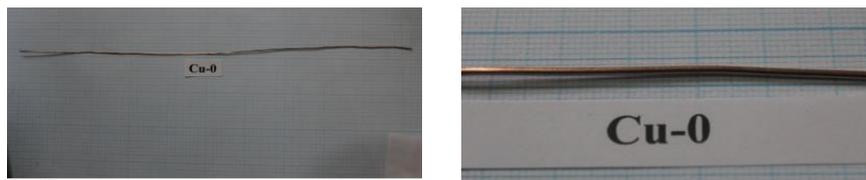
Figure 3.2 Visual inspection of the initial condition of the copper wire.

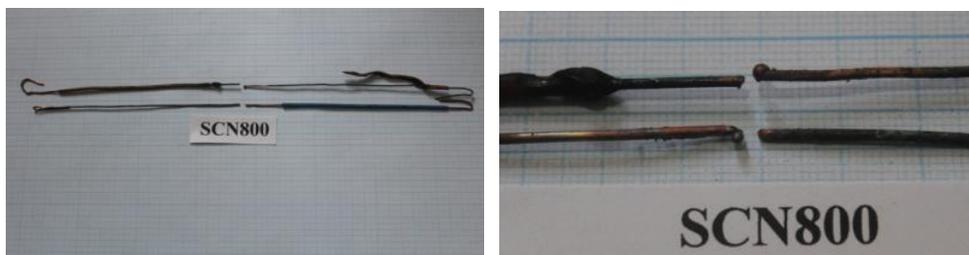
Figure 3.3 Visual inspection of copper wire of short circuit condition, current 800% ACC (144 Amperes).

Figure 3.1 shows a visual inspection of the NYM 3x1.5 electrically conducting copper wire in the initial conditions. In particular the characteristics of the beads formed in the short circuit treatment Figure. 3.3. The surface shape of the bead tip is round and smooth, the damage point is localized at a certain point, namely at the short circuit contact point. Damage areas can be identified which are interconnected from the cable conductors and the loss of material in the form of a localized basin. Also, several small bead and scratch-shaped holes scattered over a large area narrow [9].

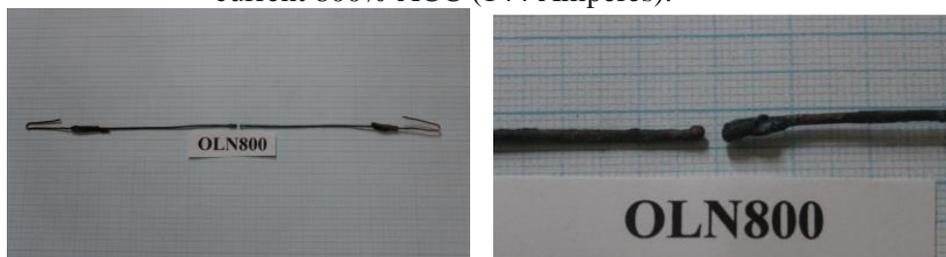
Figure 3.4 Visual inspection of copper wire of overload condition, current 800% ACC (144 Amperes).

Whereas specifically the characteristics of the beads formed during the overload treatment Figure. 3.4. The surface shape of the bead tip is round and smooth, the crash point is localized to one or more specific locations, and the damaged areas can be identified along the conducting wires.

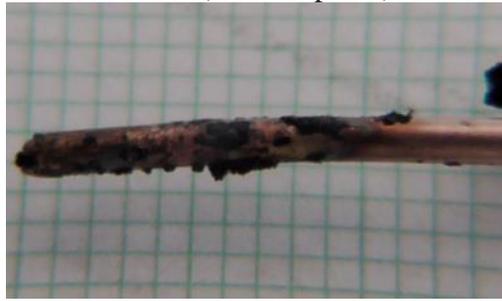
Figure 3.5 Visual inspection of copper wire of direct flame treatment, temperature 960°C.

As well as the characteristics of the beads in the form of lumps formed in the heating Treatment with direct flame Figure. 3.5. Melt wire is round in shape (different from beads), and visually, flame-melted wire does not show sharp transitions between molten/re-solidified material [10].

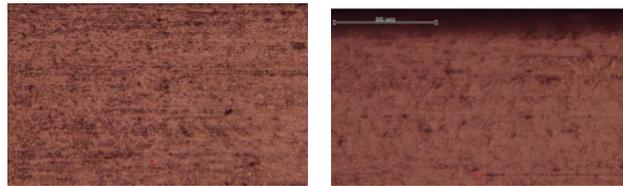
Figure 3.6 Results of examining the macro and micro structures of copper wire in the initial conditions.

1. The microstructure of copper electrical conducting wire is an alpha (α) phase with uniform and homogeneous fine grains.
2. Microstructure of copper electrical conductor wire with short circuit treatment, changes in micro structure only on the bead.

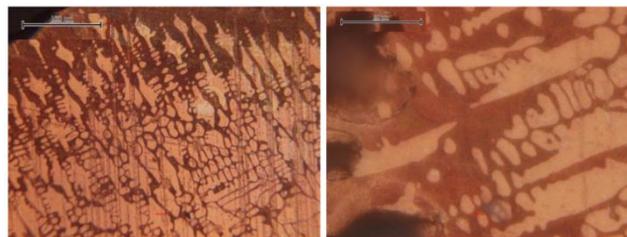
Figure 3.9 The results of examining the macro and micro structures of copper wire as a result of direct flame heating experiments at a temperature of around 960 degrees Celsius.

3. Microstructure of copper electrical conductor wire with overload treatment, there is a change in the micro structure along the conductor wire.
4. Microstructure of copper electrical conductor wire with direct flame treatment, micro structural changes occur at the tip and neck of the bead.

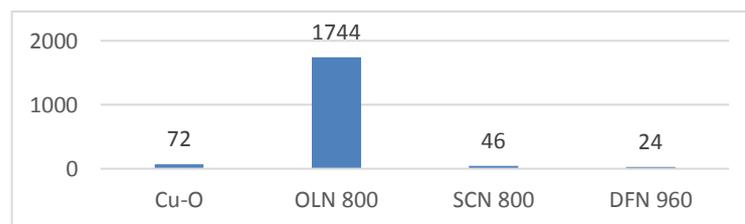
Figure. 3.10 Grain size (micron) comparison graph of various conditions of electrically conducting copper wire

In the beads due to the overload treatment (OLN 800), the heat generated occurs and is almost the same along the conductor, so that it can also cause many pieces of the conductor to occur or the beads to be formed, compared to the beads formed due to a short circuit or with a direct flame. This is what causes the grain size in the micro structure to be relatively larger compared to other treatments.

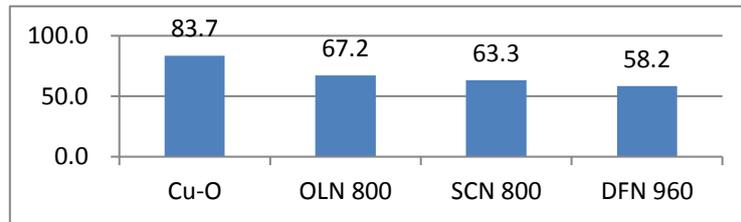
Figure. 3.11 Hardness comparison graph (HV) of various conditions of electrically conducting copper wire.

In each condition of short circuit, overload, and direct flame treatment it can be stated that the amount of current and temperature received by the electrically conducting copper wire will cause a decrease in the hardness of the copper wire.

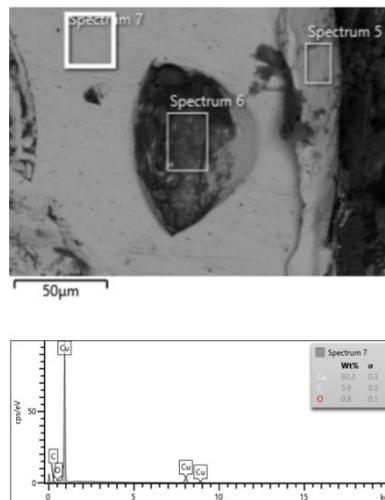
Figure 3.12 Results of SEM-EDS inspection of copper wire at initial conditions.

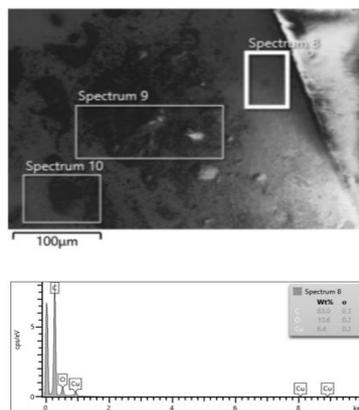
Figure 3.13 The results of SEM-EDS examination of copper wire beads as a result of the 800% KHA (144 Amperes), short circuit treatment.

Furthermore, based on the SEM-EDS examination, several things can be identified that are in accordance with the results of the macro and micro structure examination, namely as follows: Bow beads contain many voids. Top/surface layer, middle layer and inner layer are clearly visible, and the presence of elemental oxygen was detected.

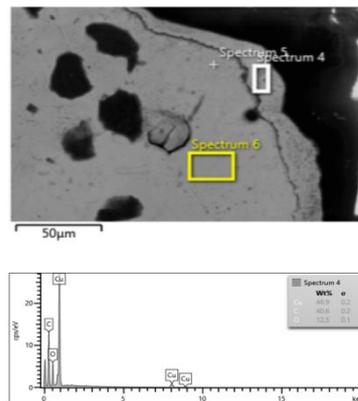
Figure 3.14 The results of SEM-EDS examination of copper wire beads as a result of the 800% KHA (144 Amperes), overload treatment.

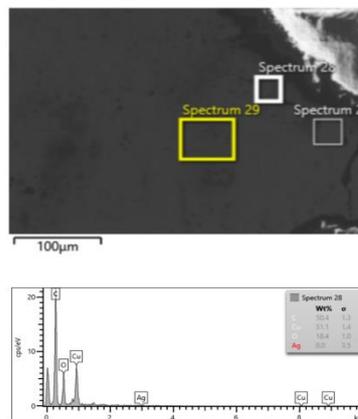
Figure 3.15 The results of SEM-EDS examination of copper wire beads as a result of the direct flame treatment at 960 degree Celsius.

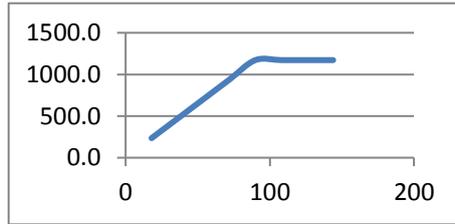
Figure 3.16 The relationship between the load electric current and the temperature ($^{\circ}\text{C}$) that occurs in the NYM 3x1.5 copper conductor in a short circuit condition.

Based on the results of the empirical calculations above which are calculated based on the time of electric current of 60 seconds, electrical disturbances in the form of short circuits or overloads indicate that for the NYM 3x1.5 type of electrical cable, the temperature will increase until it reaches the melting point of copper wire (1083°C) when energized electric current 800% ACC of 144 Amperes. Based on the graph calculation of the relationship between current (amperes) and temperature ($^{\circ}\text{C}$) shown in Fig. 3.16 and 3.17 above, it can be seen that the amount of electric current (Amperes) that can cause a temperature rise to reach the melting point of the copper conducting wire material (1083°C) in a shot circuit fault is 83.2 Amperes, while in an overload fault it is 84.7 Amperes.

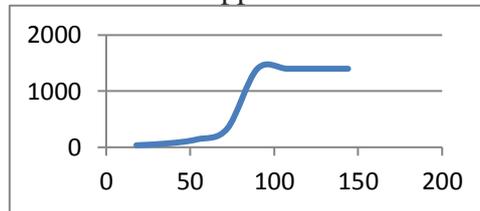
Figure 3.17 The relationship between the load electric current and the temperature ($^{\circ}\text{C}$) that occurs in the NYM 3x1.5 copper conductor in a overload condition.
