## Corrosion Behavior of a Motor-Driven Filter Pipeline in Seawater Using the Weight Loss Method: Effect of Temperature and Flow

Failure of a motor-driven filter pipeline was reported due to seawater-induced corrosion. The objective of this study was to investigate the corrosion behavior of the pipeline material in seawater under static and dynamic conditions at temperatures of 27, 40, 60, and 80°C using the weight-loss method. Surface characterization was performed using scanning electron microscopy coupled with energy-dispersive spectroscopy (SEM-EDS) and X-ray diffraction (XRD). At 80°C, both static and dynamic conditions exhibited corrosion rates approximately twice those observed at 27°C. SEM observations revealed the formation of a dense and adherent corrosion-product layer at 27°C. However, at 80°C, cleavage and cracking of the corrosion-product layer were observed, allowing corrosive species to diffuse more readily to the metal surface and thereby accelerating corrosion. XRD analysis confirmed that the corrosion products consisted primarily of Fe<sub>2</sub>O<sub>3</sub> (hematite) and Fe<sub>3</sub>O<sub>4</sub> (magnetite).

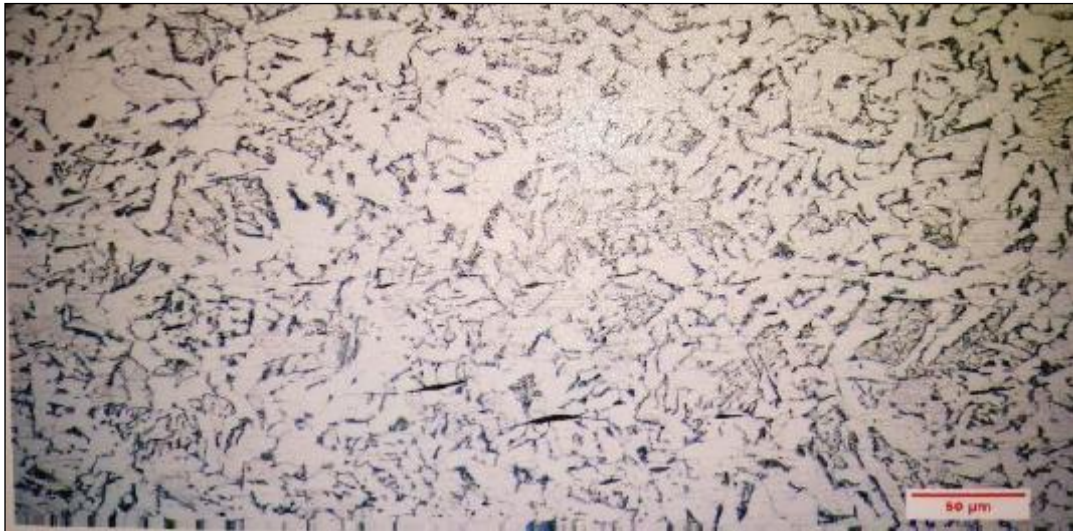
The specimens were prepared from the failed pipeline. The specimen dimensions were 20mm length, 20mm width and thickness of 10mm. Prior to be used for experiments, the prepared specimens were treated using pickling method according to ASTM G1-90 [7]. The pickled specimens were then cleaned and washed using distilled water, acetone and stored in vacuum desiccators. The samples were weighed for the initial weight before immersion test using analytical balance (accuracy of  $\pm 0.0001$  gr). As shown in Figure 1, Optical microscopy revealed that the microstructure consisted predominantly of ferrite and pearlite, indicating that the material is a carbon steel. The observed microstructure is typical of carbon steel commonly used in seawater piping applications.

**Figure 1.** Microstructure of the sample.

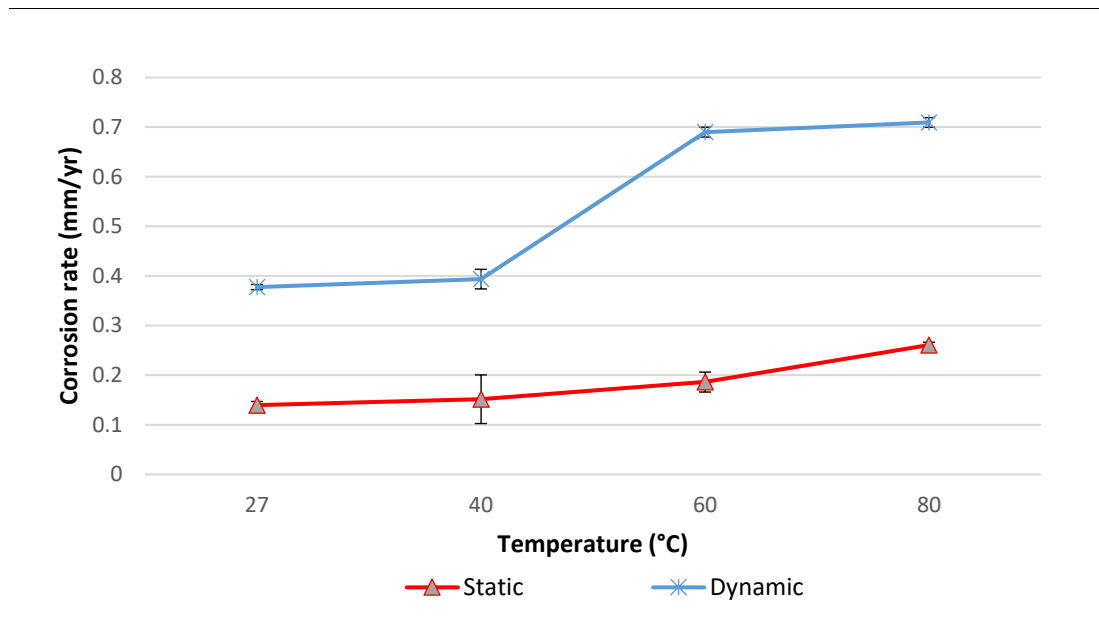
**Figure 3.** Corrosion rate of carbon steel at various temperatures (27, 40, 60 & 80°C) in static and dynamic condition. Error bars represent  $\pm$  standard deviation based on triplicate measurements ( $n = 3$ ).

From Figure 3, it is observed that the corrosion rate at temperature 27°C is 0.14 mm/yr and increases up to 98% (0.26 mm/yr) at temperature 80°C. In the dynamic conditions, no significant increasing of corrosion rate at temperature 27°C to 40°C and 60°C to 80°C. However, significant corrosion rate increment (approximately 90%) was observed when the temperature increases from 40 to 60°C.

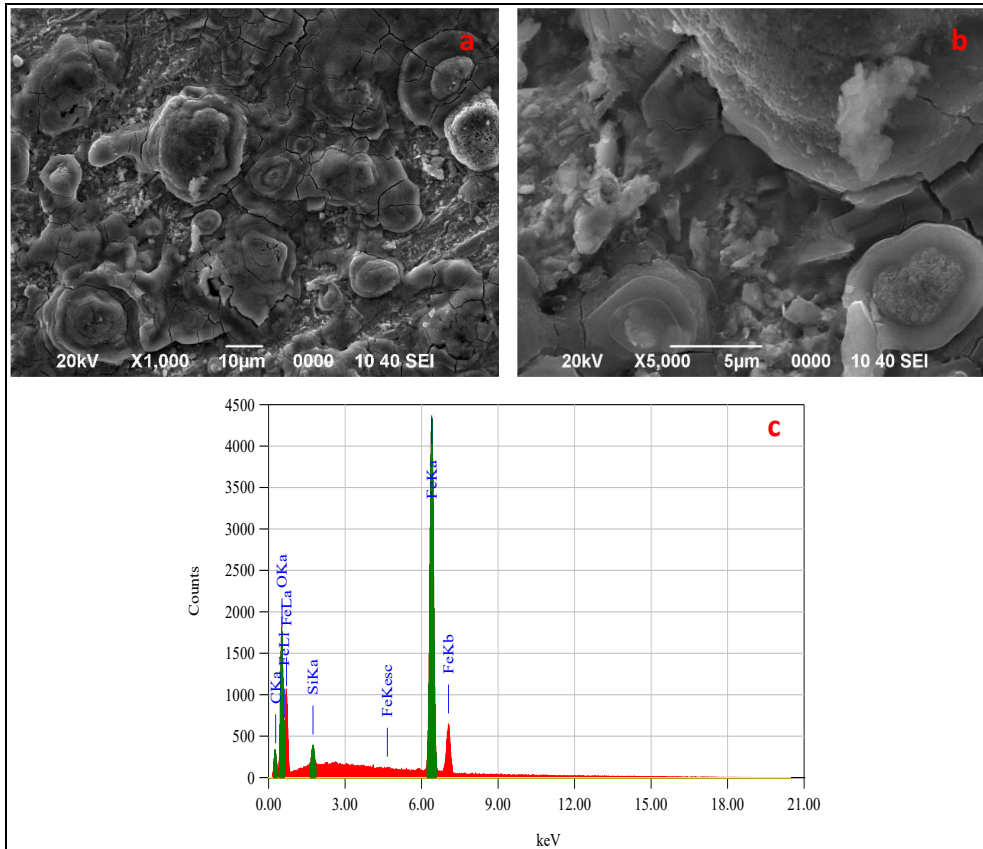
Scanning electron microscope of carbon steel in treated seawater at temperature 27 and 80°C in static and dynamic conditions could be seen in Figure 4 to Figure 7. In static condition, at temperature 27°C, SEM showed film formation on the surface of carbon steel. It is observed that there were two layers of film formed. The first layer was characterized by spot of oval film with distinctive cleavage on its surface. While the second layer, was uniform film covered the steel surface. At temperature 80°C, it is seen that the characteristic of the film was changed. The first layer of the film was vanished and the second layer of the film was composed of fibrous typical film that might caused diffusion of corrosive species to the steel surface, hence increased corrosion rate.

**Figure 4.** Scanning electron microscope of carbon steel in treated seawater at temperature 27°C in static condition: (a) 1000 X magnification (b) 5000 X magnification (c) EDS results.

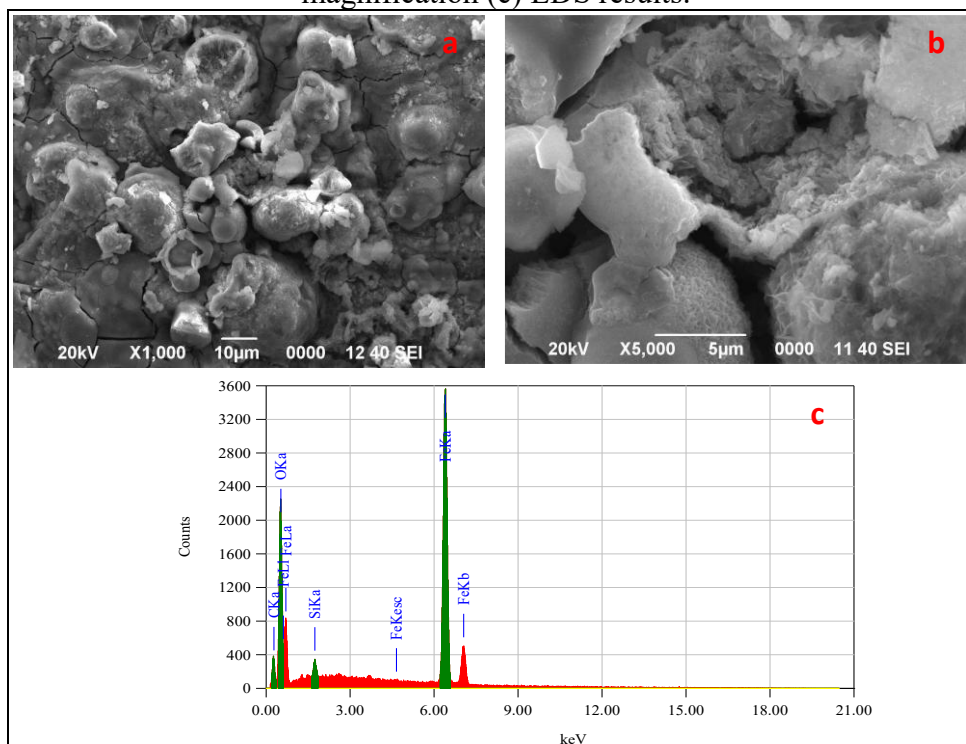
**Figure 5.** Scanning electron microscope of carbon steel in treated seawater at temperature 80°C in static condition: (a) 1000 X magnification (b) 5000 X magnification (c) EDS results.

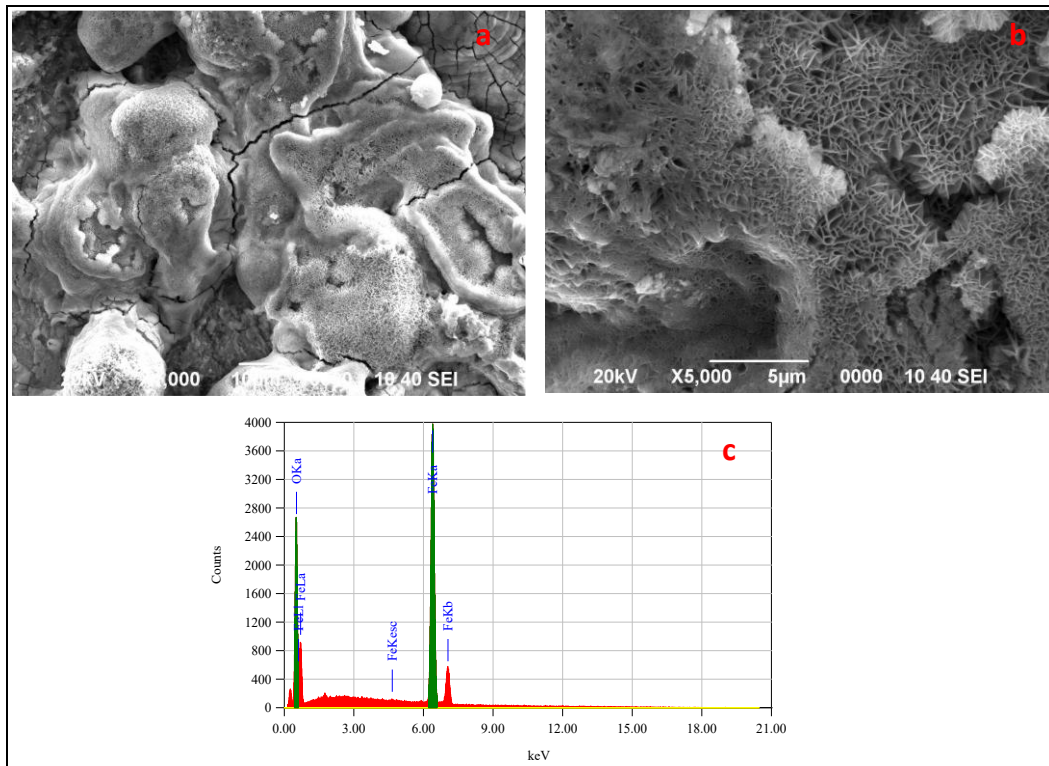
In dynamic condition, at temperature 27°C, the cleavage of the film is observed and more apparent in temperature 80°C, thus increasing corrosion rate. EDS results showed the element of Fe, C and O on the film formation at both temperature (27 and 80°C) in static and dynamic condition.

**Figure 6.** Scanning electron microscope of carbon steel in treated seawater at temperature 27°C in dynamic condition: (a) 1000 X magnification (b) 5000 X magnification (c) EDS results.
